New Design LYNX 40 Feed Box

DML DML Industries

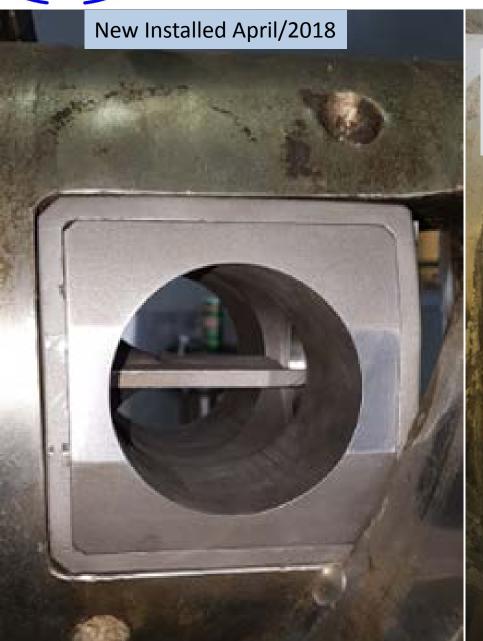
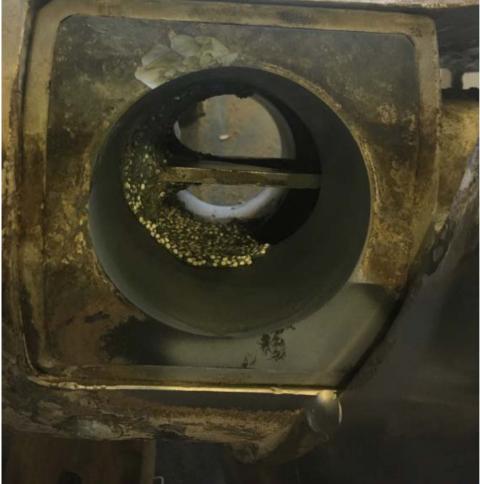
After 3,100 hrs

"Feed box looks good- not much for wear, the accelerator and feed bushing look good and there's a slight bit of rippling inside of the carbide feedbox itself but hardly noticeable."

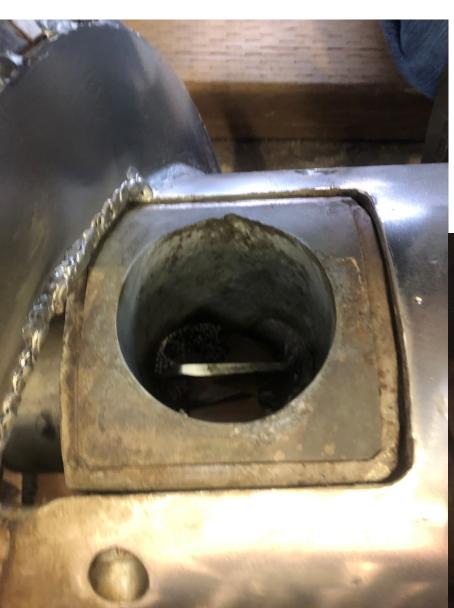
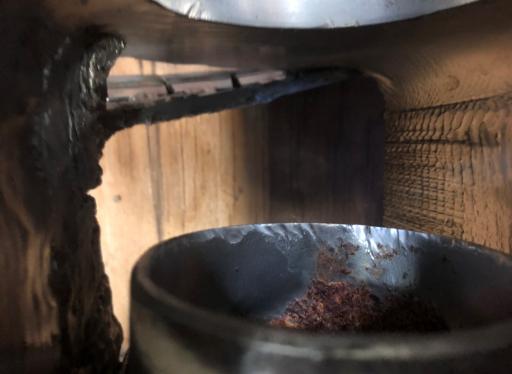
Initially Installed April/2018 --- The unit came through for repairs a few times but, the Feed Box wasn't touched until now (Feb/2021), it was cleaned up and put back into service in the same position.

"I have attached a few pictures of the 2 port that has come through - you can see a bit of where on the carbide feed box and a little bit of wear in the feed bushing. Accelerator plate looks in good shape still.
